Rottal Burn Restoration

Rottal Burn Restoration December 2012 *River Restoration* NEWS

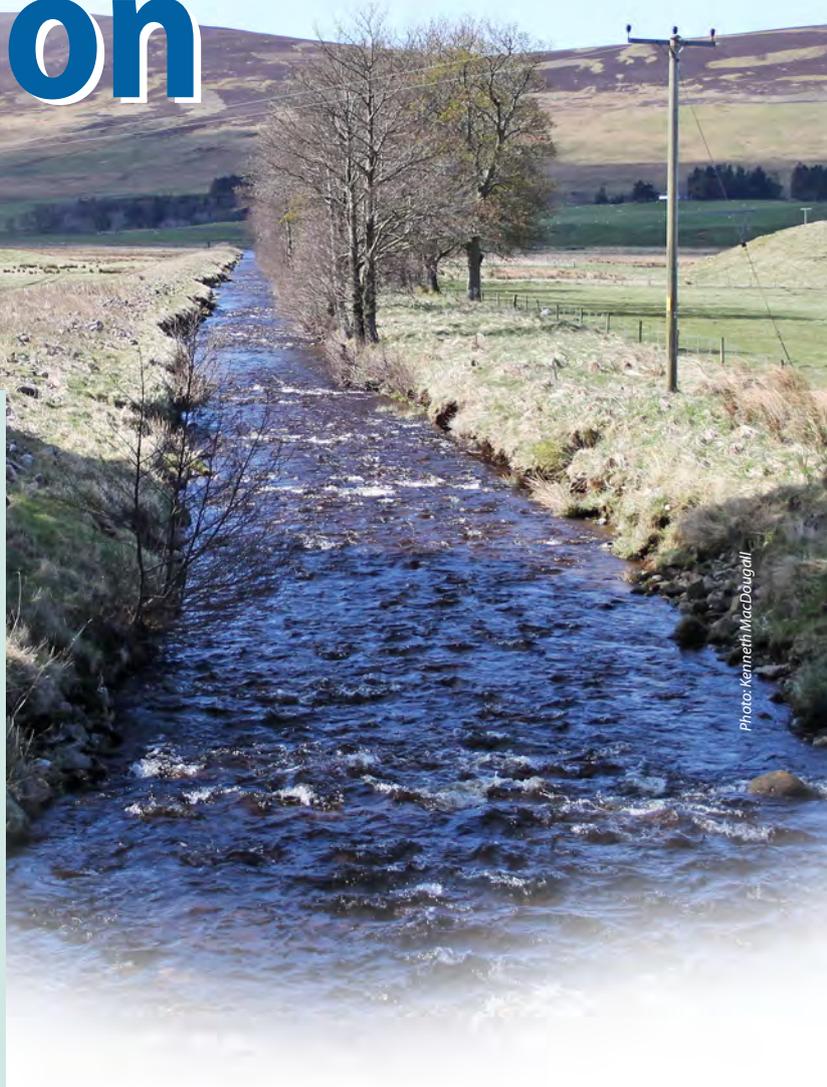
Photo: Kenneth MacDougall

The lower reaches of the **Rottal Burn in Glen Clova** have been transformed this summer. The burn that flowed through 650m of straightened, embankment-lined channel since the 1830s has been restored to an open, meandering channel 1,100m in length. These works aimed to restore natural river process, providing increased and more varied in-stream and riparian habitat within a designated **Special Area of Conservation** for Atlantic salmon and freshwater pearl mussel. Within just 10 weeks of the burn flowing within the new channel, there is already a significant increase in the variety of habitat present and salmon have started spawning.

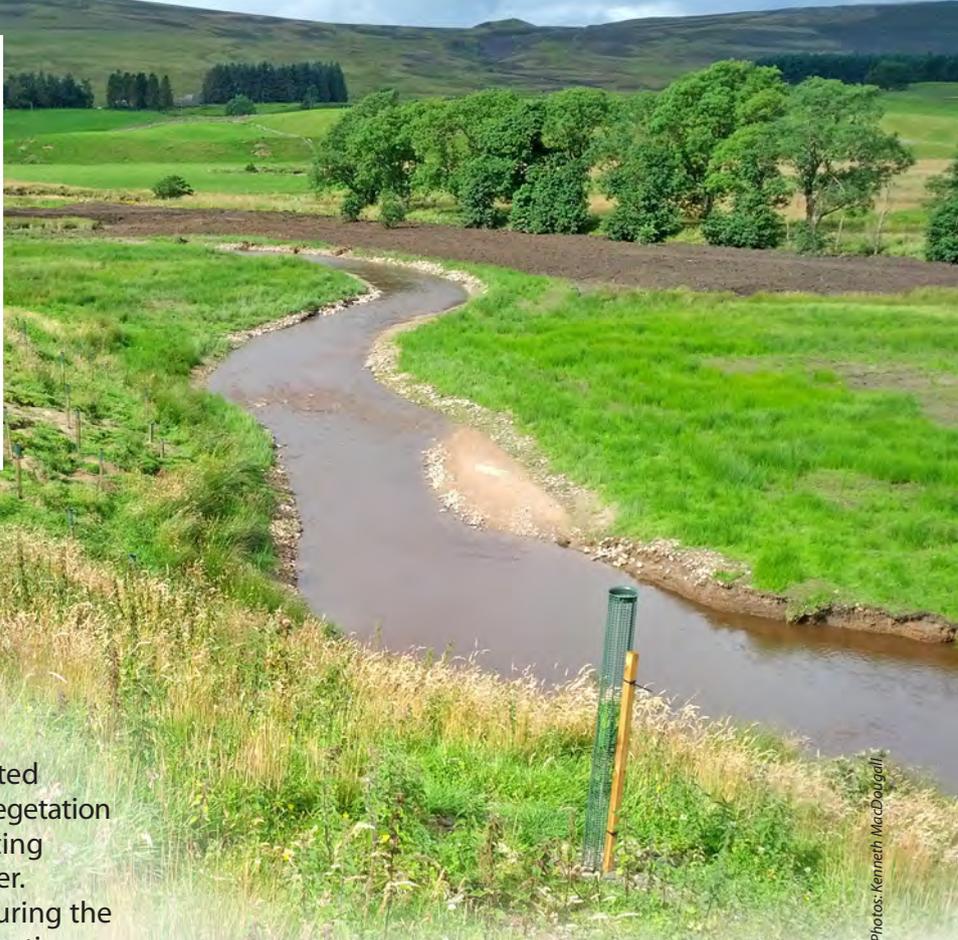
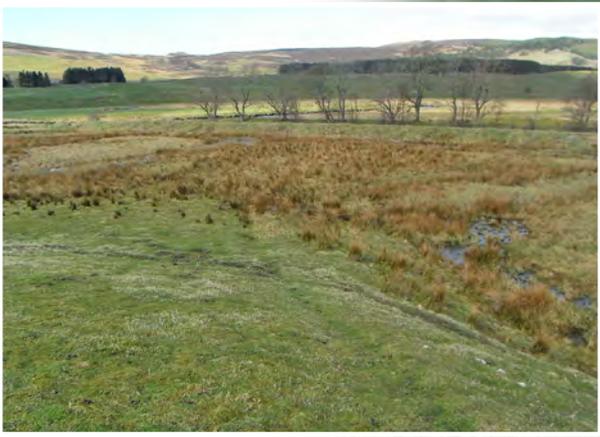
Photos: Kenneth MacDougall

Restored natural channel. Inset (top left) shows the river before restoration

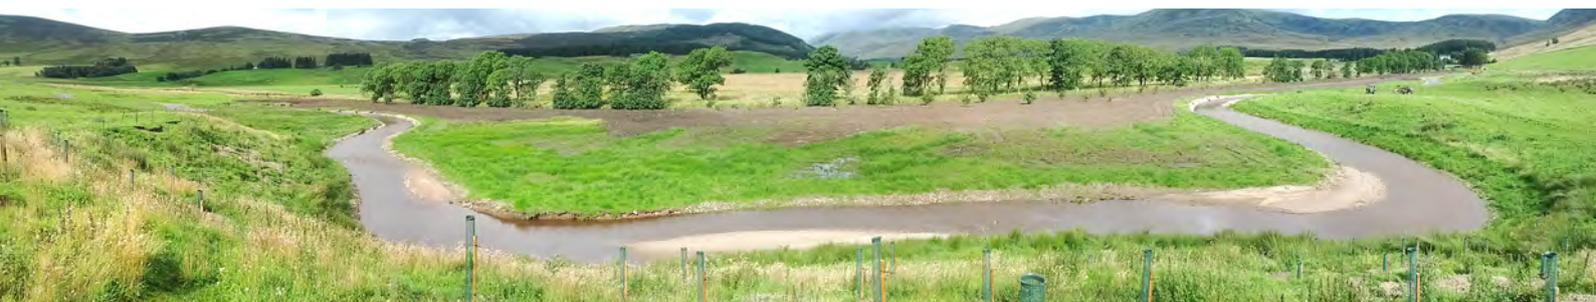
Panoramic view of the restored Rottal Burn
